ACTION RESEARCH PROJECT REPORT

Piloting and knowledge co-creation on the nature-based solution to protect wave erosion in haor areas of Bangladesh

August 2024

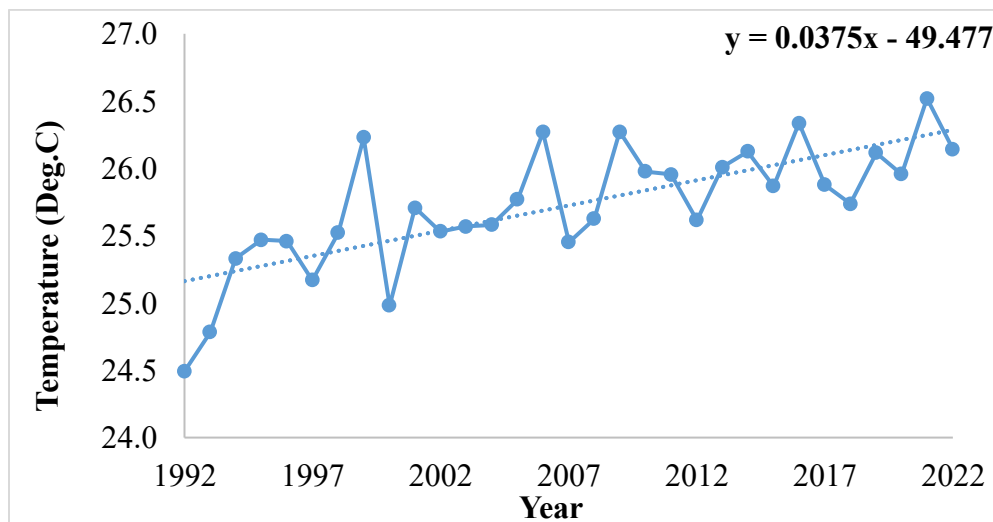
Figure 1: Average temperature of Tahirpur (Sylhet station) (1992-2022)

The average temperature in Tahirpur has increased from 1992 to 2022. The annual rainfall trend was also found with an increase in Tahirpur for the same period. The annual rainfall is following an increasing trend of 15.165 mm/year (**Figure 2**), and the average temperature is increasing by 0.0375 °C/year (**Figure 1**).

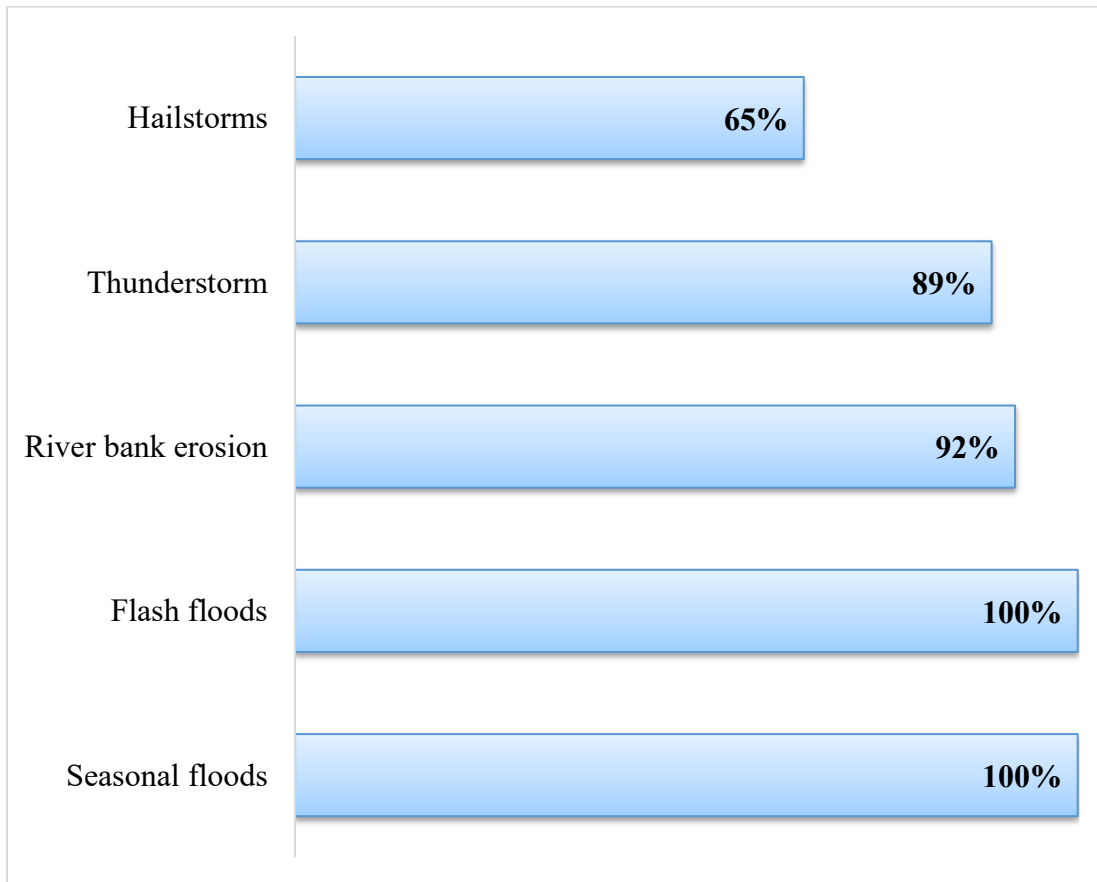
Figure 3: Disasters in the study area

The recent trends of climate-induced extremes (flash floods, seasonal floods, river bank erosion, thunderstorms, and hailstorms) are common disasters in Tahirpur. According to all of the respondents in the study area, seasonal floods and even flash floods are common in Tahirpur. Also, they suffered from different climate-induced disasters, such as riverbank erosion, thunderstorms, and hailstorms, as mentioned by 92%, 89%, and 65% of respondents, respectively (**Figure 3**).

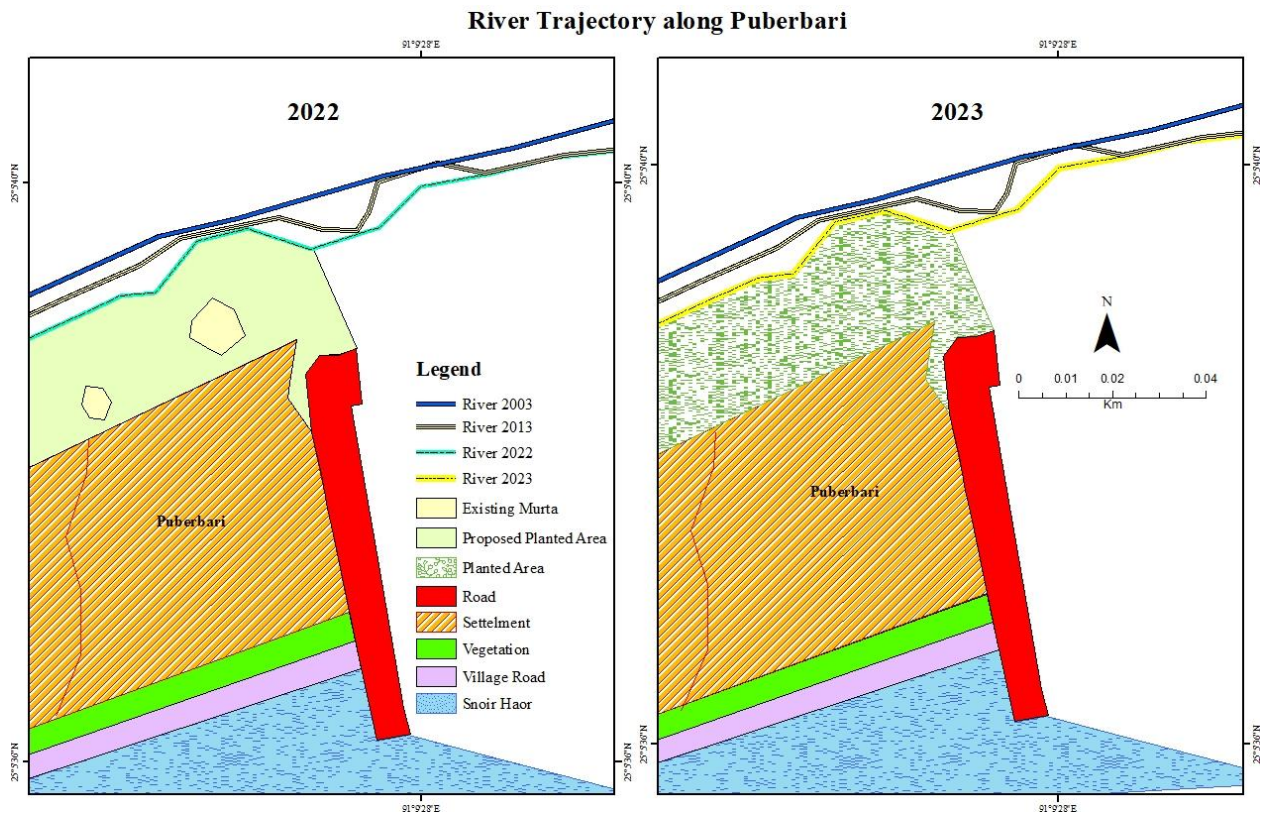
Map 5: River trajectory and land erosion in the NbS location

Similarly, land erosion also improved. In 2003, there were 0.582062 Ha of land in the Haor; however, in 2023, it stands at 0.548758 Ha and decreased by 0.033 hectare due to erosion. In 2023, it stands at 0.518403 hectares and decreased by 0.033 hectares due to erosion (Table 5, Map 5). The application of NbS reduced erosion.

In 2013-2022, the Boulai River shifting was found to be 0.26 meters; however, by the application of Murta as NbS, the river shifting scenario has improved, and in 2022-2023, only 0.09 meters was shifted (Table 4)

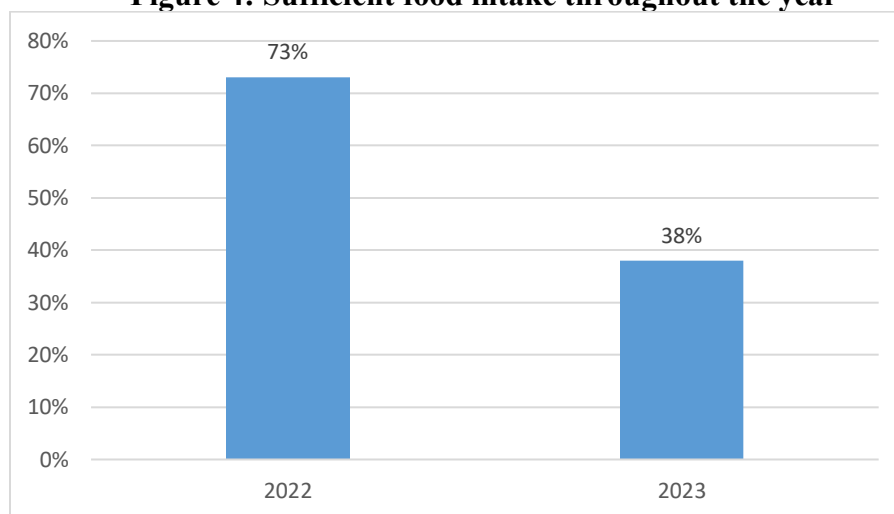
Figure 4: Sufficient food intake throughout the year

Before the NbS application, a significant number of project participants (73%) did not have adequate food for all year, while 38% were insecure after the NbS application. said "no." This graph shows that the majority of people have constant access to an adequate food supply, but a significant minority still confronts food insecurity (Figure 4).
